PARTEK SKI LIFTS
482 Newport Bridge Road
Pine Island, NY 10969
845-258-4552 845-258-4537 (fax)
800-626-4165 (toll free)
E-mail: partek@aol.com

SERVICE BULLETIN NUMBER 02-030510

SUBJECT: CRACKS IN ROPE GRIP BODY JAW

REFERENCES: DRAWING C-2715

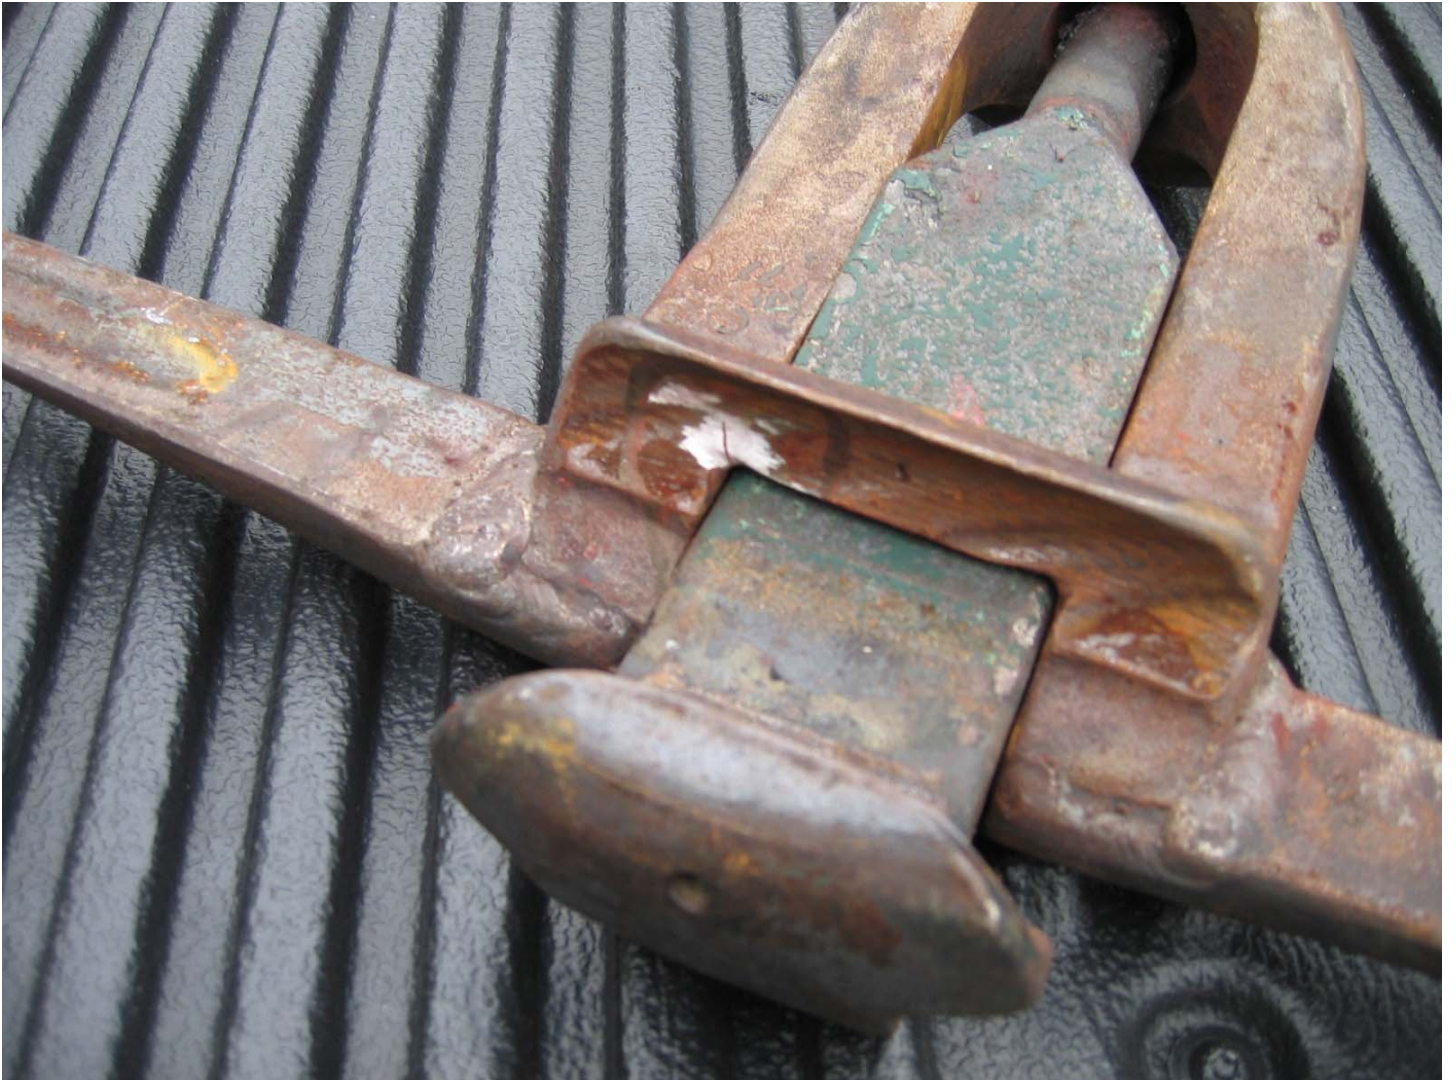
Critical indications have been discovered in the jaw area on the main grip body of the above mentioned grips that will require this model of grip to be removed from service in stages. The bulk of these grips were supplied on Borvig lifts from 1976-1980. Some lifts built in 1975 and in 1981-2 may not be affected since they were supplied with a different model of grip. If your lift does not have this particular style of grip, this bulletin does not affect your lift.

The cause of the failures is due to several factors, in many cases a combination thereof. Metal fatigue is the primary cause. In some cases, severe coining of the grip jaw, poor maintenance of bullwheel liners, gaps in bullwheel liners and the use of hard urethane sheave liners have contributed to the failure. These grips have been in service for over 30 years and have endured many millions of cycles passing over sheave assemblies and around bull wheels.

Photo Of Crack

The affected grips are to be replaced as follows:

- 1/3 Prior to 11/15/10
- 1/3 Prior to 11/15/11
- 1/3 Prior to 11/15/12

All existing grips will have to be 100% NDT tested in order to establish how many grips have indications. If more than one third are found to have indications, those additional grips will also have to be replaced prior to 11/15/10.

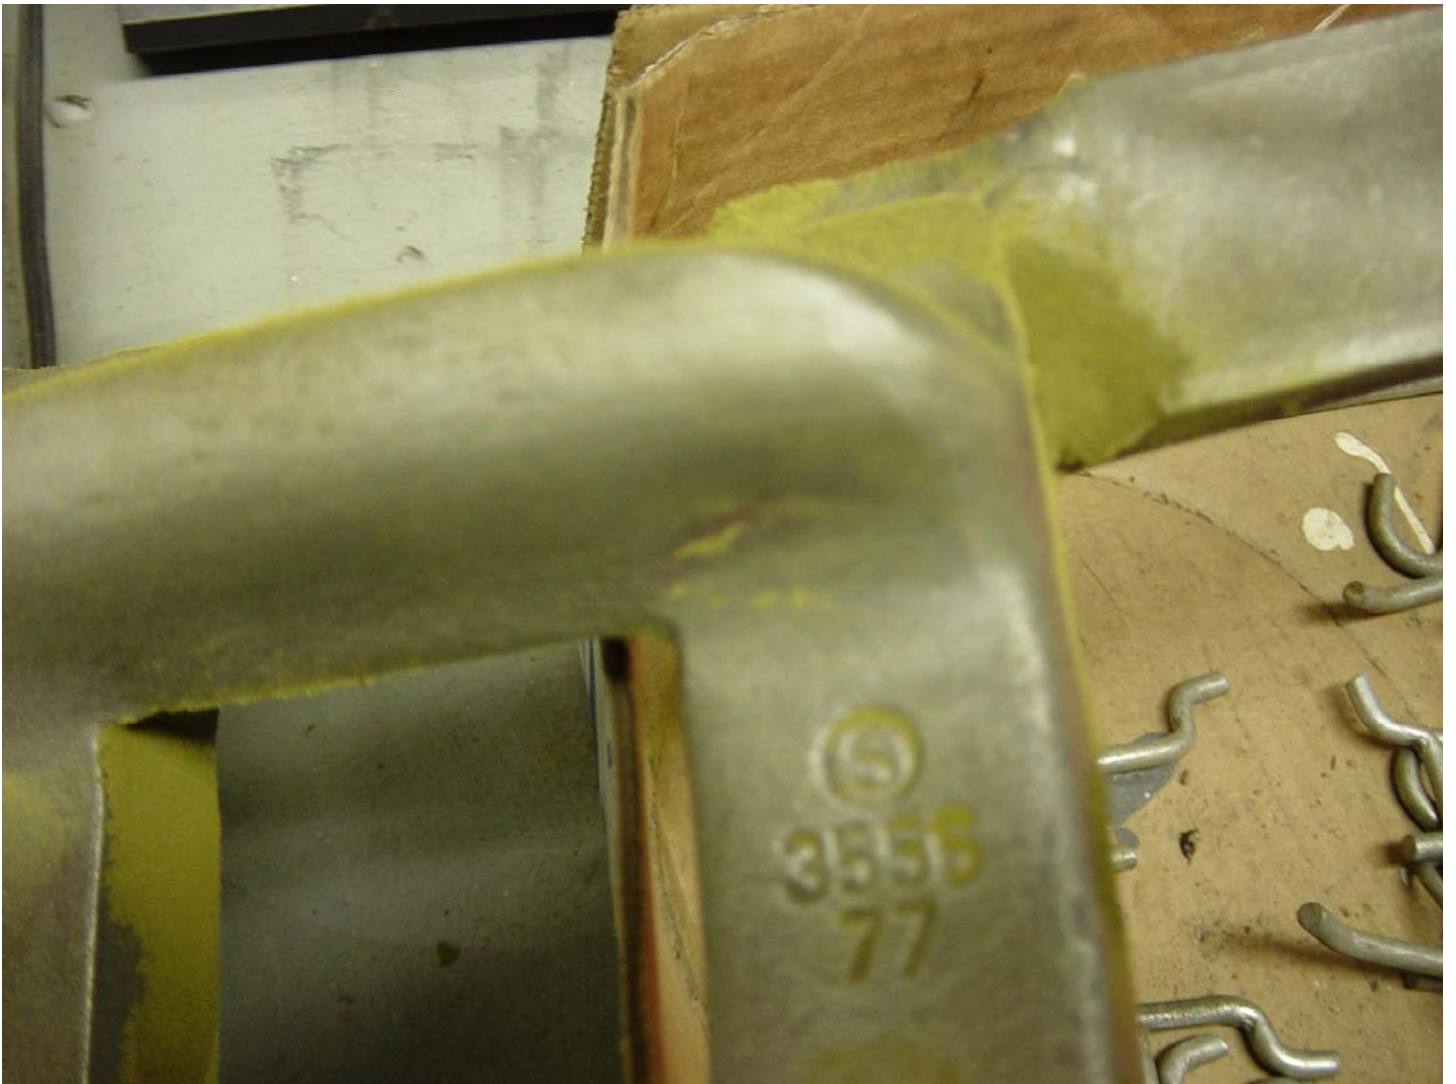
According to our records, there are 2,888 of these grips that were supplied by Borvig. Some have already been replaced. These grips can easily be identified, the main journal where the chair head attaches to the grip is 65mm in diameter with two snap ring grooves, 24 spring washers and the grip body has welded metal grip guides. Later models had pivoting metal grip guides and even later models used plastic grip guides, they are not affected by this bulletin. The year of manufacture is cast in the grip as "75", "76", "77", "78", "79", and "80". Most were delivered in 1977, 1978 and 1979.

Grip Year Identification
